INSPECT YOUR RING FEEDER

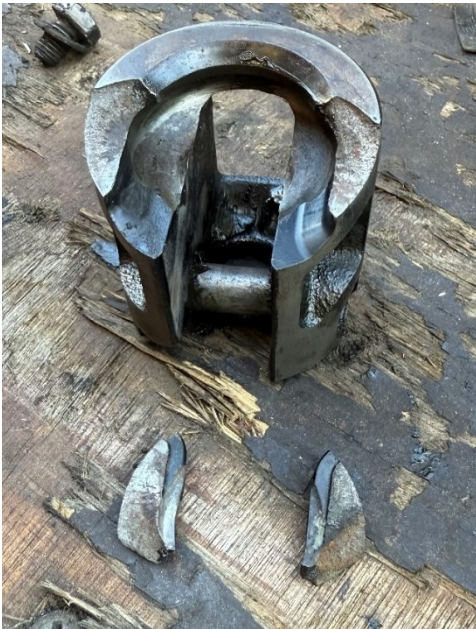
Due to a ring feeder coupling failure it is recommended to have the Ringfeeder model with the red locking tab inspected by your Service Provider (see photo on right).

Signs of excessive premature wear has been found on the top of the pin where it sits in the lift cradle.
