Review of Driver Protection During Log Truck Unloading

Prepared for:

Log Transport Safety Council

April 2024

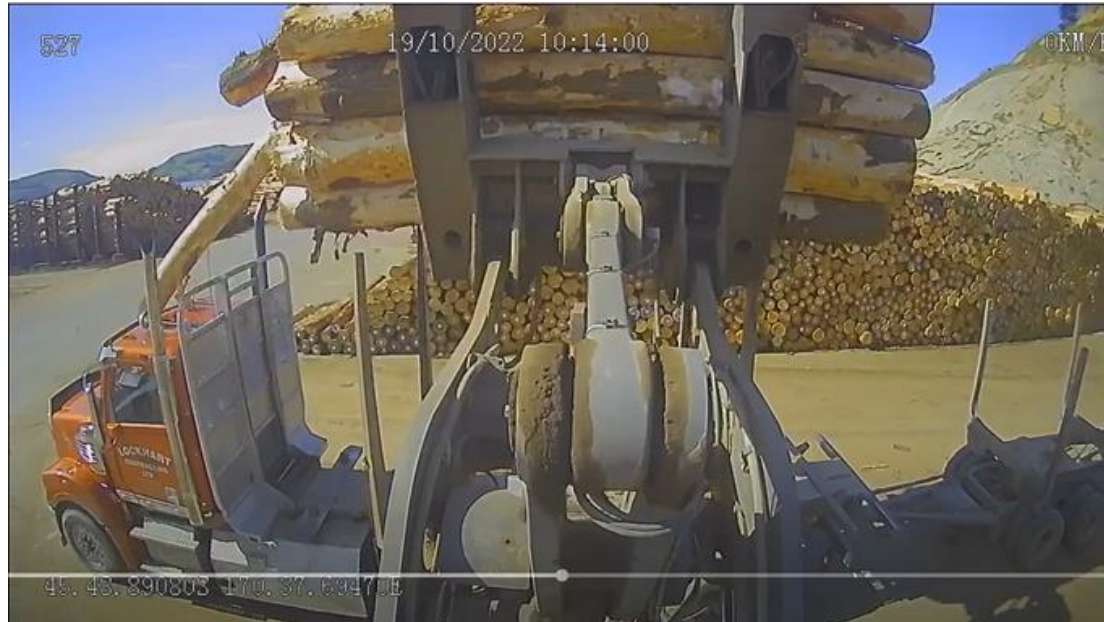
Figure 1. Example of log impacting truck cab roof.

This loading, however, is a static load applied across the whole roof of the cab. The typical loading situation that we are concerned with is a single log slipping out of the grip of the loader and impacting the roof. An example is shown in Figure 1 below.

At the time of impact, half of its weight is supported by the packet in the loader and half impacts the cab roof, but the impact force is significantly higher than half the weight. For example, if the log has fallen from 1.5m above the roof and makes a 0.3m dent in the roof, the deceleration on impact is 5g meaning that the impact force would be 2.5 times the log weight.

The maximum weight of a log is about 2000kg, although the log in Figure 1 weighs much less than this. Even with the heaviest logs, this force is still well below the UNECE R29 test load, but it is applied to a very localised area of the cab roof rather than uniformly across the whole roof. Furthermore, we do not have data on the heights that the logs could fall from or the magnitude of the resulting dents. However, we do know that, to date, there have been no significant injuries to drivers because of these incidents.
