# SAFETY ALERT

## Electronic ring feeder release system

**On Tuesday 21st January, a self loading log truck became detached from it's trailer on SH30.**

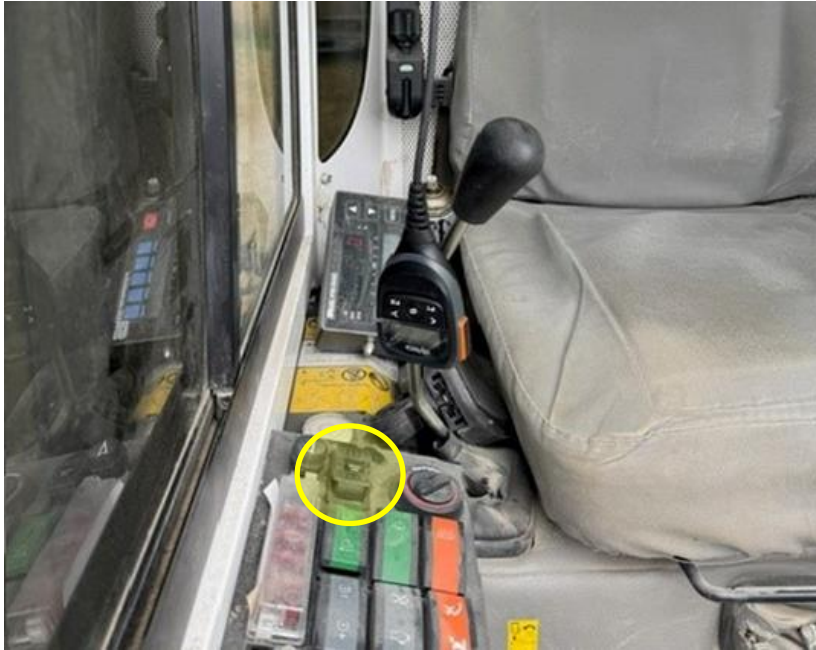
- Inspection of the ring feeder and tow eye found them both in good working condition.
- During the investigation it was revealed that the truck was fitted with an electronic ring feeder release system, operated from the cab of the crane.
- This system had been installed with a simple switch.
- During the journey a recently installed RT had become dislodged and has struck the switch, thus releasing the ring feeder.

- Any electronic release system for a ring feeder – must have safety redundancy incorporated.
  - It is recommended that a two-step switch is installed and that the switch is only enabled when the PTO is engaged.
-
