SAFETY ALERT

TRAILER BRAKE ALERT Yard Valves

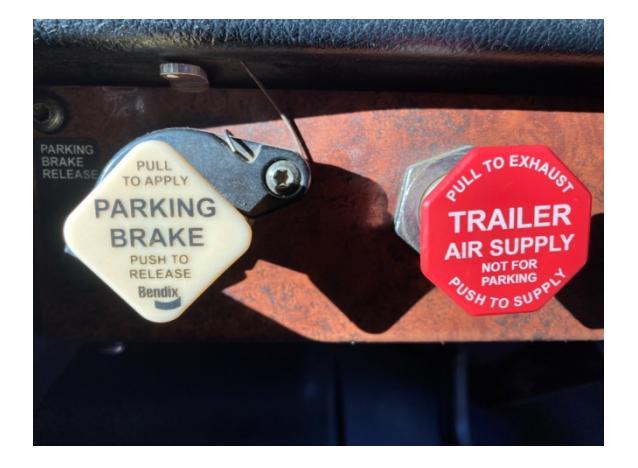
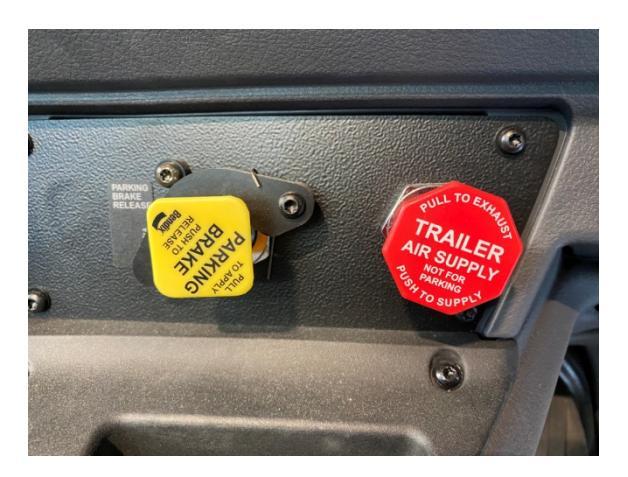
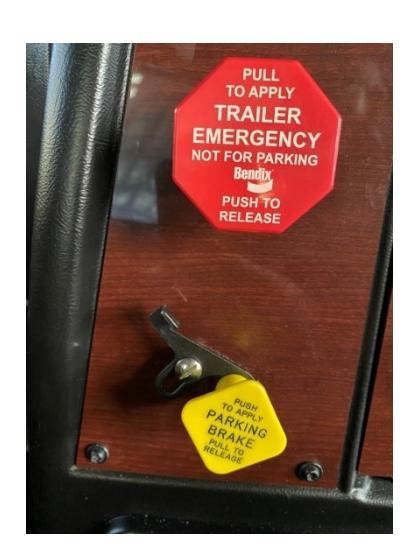
These buttons are commonly found in Western Star, Mack, International and Kenworth Trucks and are similar to the pictures included in this alert.

An issue can arise when a driver activates the yard release valve on a trailer but then fails to activate the red trailer release button in the cab of the truck before moving away. Failing to activate the red button and only activating the yellow truck release button could result in the trailer being towed with no brakes being active on the trailer.

The red button must be activated to reset the yard release valve on the trailer so air is supplied to the brake system on the trailer.

Please ensure all drivers of trucks with the above system are aware of the risk and if they are using the yard release button fitted to the trailer, they must ensure they reset it before moving. All drivers should check that both buttons fitted to the dash are charged or activated before moving off when towing a trailer.

Truck manufacturers may have solutions that can be retrofitted to avoid this from occurring which LTSC suggests you discuss with your specific supplier.
