SAFETY ALERT

Findings from investigation into a fire involving Mobile Plant at Ports of Auckland

PORTS OF
AUCKLAND

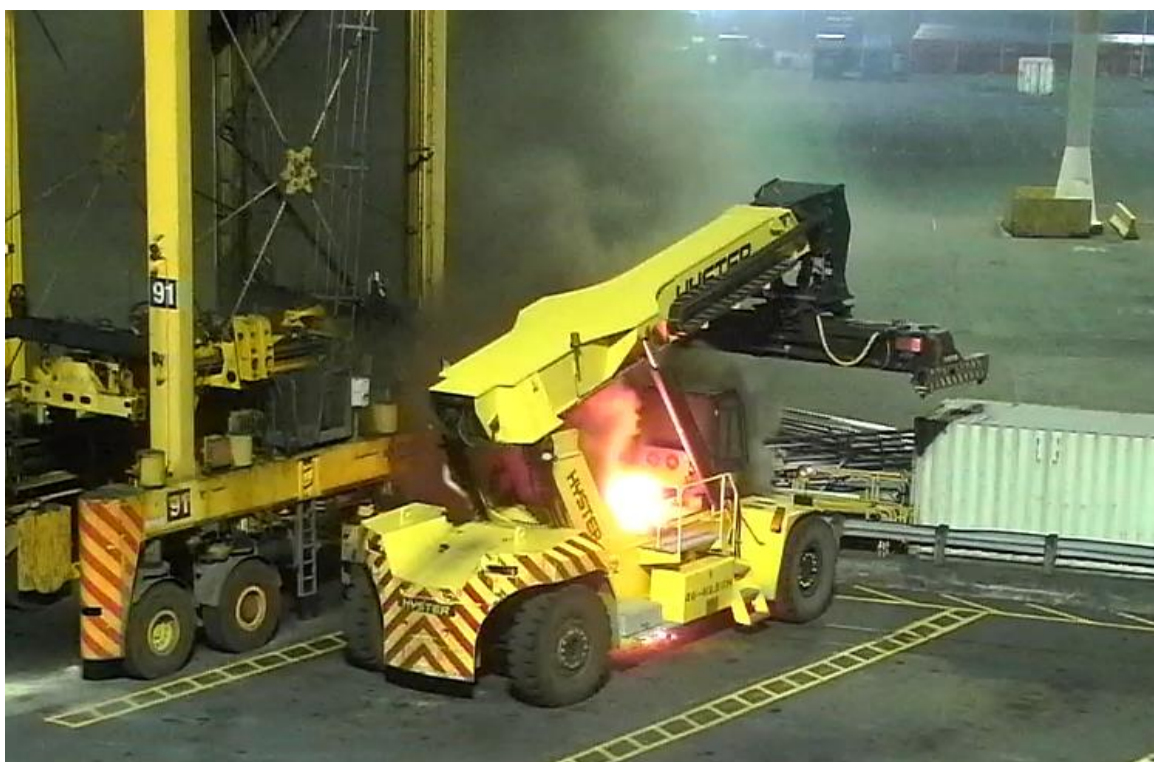
These flames quickly developed into a fully involved fire which significantly damaged the entire engine compartment and components within, as well as the rear of the operators cab and other components fitted to the exterior of the machine.
