**SELF
LOADER
LOGGING**
Limited
TAUPO

SAFETY ALERT

20th MAY 2026

TRAILERS FITTED WITH SPRING TENSIONED LIFTING CHAINS

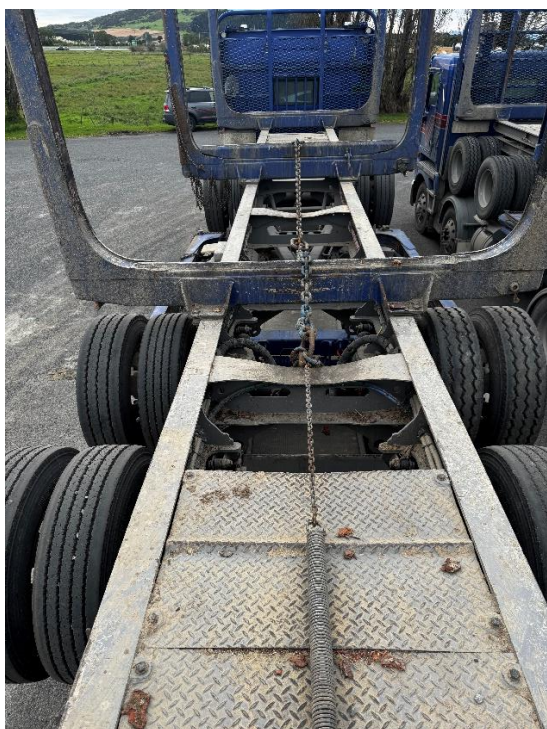
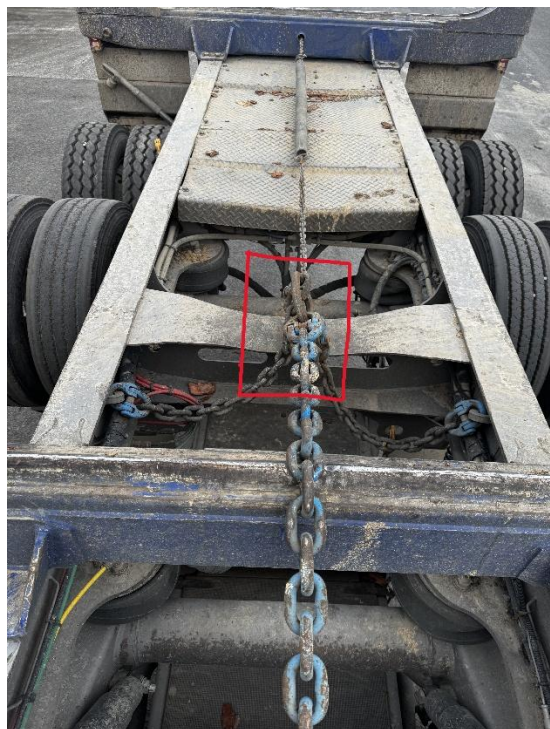
- What Happened:** A driver has suffered an injury at the Kawerau gantry while preparing his trailer for lifting.
- How It Happened:** As he pulled back on the tensioner chain from the rear of the trailer one or both of the main lifting chain bridle connectors caught on the 3rd bolster or chassis crossmember then suddenly released.
- Outcome:** The driver has sprained his forearm / elbow & been declared medically unfit for work. A positive return to work assessment by an occupational therapist will be required before resuming normal duties.
- Learnings:** Keep an eye on the lifting chain.
Adopt a standing position that allows the body to twist with the tensioning movement.
Being mentally aware allows you to be physically prepared for potential sudden movement.
